## C7 SERVICE ADVICE

NCR 11983 1 of 3

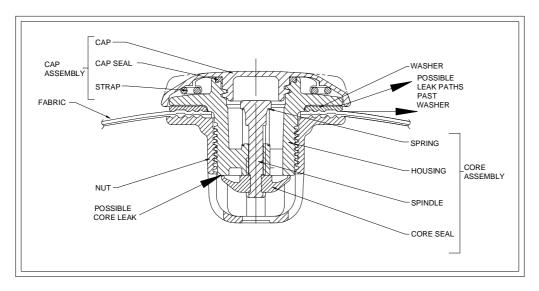
First identify where the leak is coming from- see diagram below.
